# Medical Equipment at Kilimanjaro Christian Medical Centre and Mawenzi Regional Hospital

EWH Summer Institute, June 17 - August 17 2014

**Assessment of Donations and Report of Repairs**

Report, August 17 2014

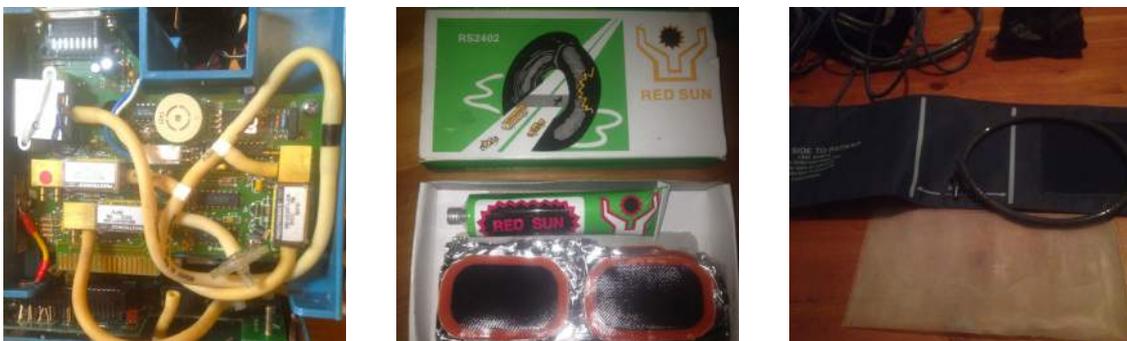
**Figure 3.1:** Aged tubing was one of the most common and simple fixes we encountered. Left: A Vital Signs Monitor, illustrating the amounts of tubing often found in medical equipment. Center: Aged rubber can simply be fixed using normal vulcanizing rubber bicycle patches. Right: A typical blood pressure cuff that can be repaired using bicycle patches as the bag is made of plastic. 5.6

**Leaky Tubing** Leaks were commonly encountered in malfunctioning equipment. These were often seen in the rubber bags and tubing of both automatic and manual blood pressure cuffs. Because of these leaks, the blood pressure machines failed to reach an adequate pressure to take a measurement. If the leak was not easily found by observing the tubing or feeling air escaping from the cuff, a simple test helped to determine the problem area. First, the cloth casing was removed. Next, the bag was inflated, and both bag and tube were submerged in a bucket of water. The leak was then easily identified by the escape of air bubbles from the hole. Once the leaks were identified, they were repaired at a local bicycle repair shop on Sokoine Road with a rubber tire patch. This process involved roughening the leakage spot with sandpaper, applying vulcanizing glue, and covering with a bicycle patch. An extra bicycle patch kit was purchased and given to the KCMC engineering department to repair future leaks. Leaks can also be found by covering the sus-

pected area with a soapy solution. The passage of air through the solution will create bubbles, indicating the source of the leak. This technique was used on an oxygen concentrator to find a hidden leak at a bolt junction.

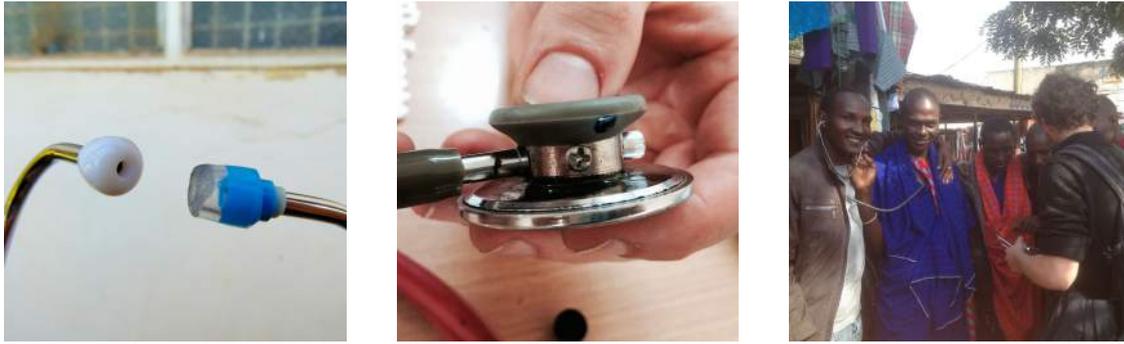
**Figure 3.2:** Left: New Earbud for stethoscope using a small and a large diameter tube. Centre: Fixing a stethoscope. The screw for the stethoscope Right: Testing the newly fixed stethoscope with help from local Maasai.

**Stethoscopes** Stethoscopes, found in many departments, commonly lose the rubber earpieces after prolonged use. These were made with various sized tubing placed inside of each other to make a contoured shape earpiece. The tubing should then be shaped using sandpaper. The rubber tube earpieces are attached to the stethoscope handles using epoxy.

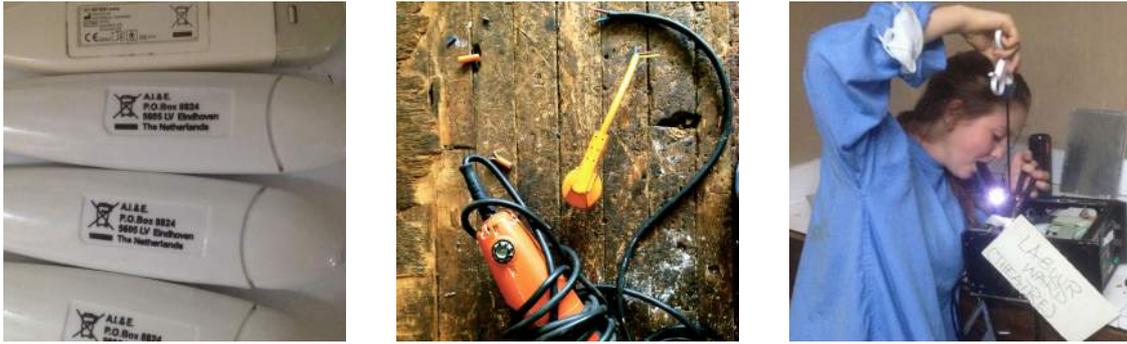
**Figure 3.3:** Left: Four broken thermometers we were given by the medical ward, which all worked after changing the batteries. Center: Cast cutter that needed a different plug. Right: Tubing often stretches and cracks over time, increasing the likelihood of leaks. Here, Ashley is repairing an automatic blood pressure monitor by replacing the old tubes with newer tubing cannibalized from an old blood pressure cuff.

**Batteries** Some of the simplest fixes involved thermometers and digital blood pressure cuffs, which simply required replacement batteries. LR41 button batteries were purchased from the "fundi wa saa," the watch technician, along Mawenzi Road. The rusty battery connections in the thermometers had to be thoroughly cleaned with alcohol swabs before the batteries were replaced.

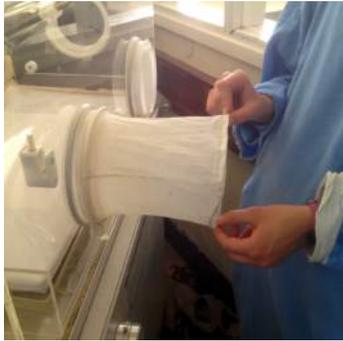
**Figure 3.4:** Plastic Sleeves of the Incubator

**Arm Sleeves** Replacements were not available for the missing plastic arm sleeves that cover the inlet holes, so we had to invent our own solution. The fabric for this part had to be waterproof and airtight, so we bought a 100% polyester shower curtain from Nakumatt Supermarket in Moshi Town. A seamstress on Uru Road created five arm sleeves, modelled after a worn-out plastic sleeve found with the machine. These sleeves had elastic bands on each end that could be fastened to the incubator and tightened to seal the air when not in use. They were also removable and washable. Extra fabric was stored below the incubator in case a replacement sleeve is needed in the future.

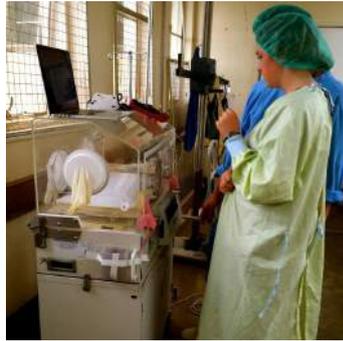
**Figure 3.5:** Testing the Incubator

After troubleshooting, the first step was to test if the problems could be solved with temporary solutions. The open inlet holes were covered with plastic gloves and grocery bags, the missing latch on one of the entry doors was replaced with tape, and the cracked container for the water humidifier was sealed with tape. After these these temporary fixes were made, the incubator was tested for one hour and no alarms sounded. This approach ensured that the machine was functioning correctly before we invested the time in more sustainable fixes.

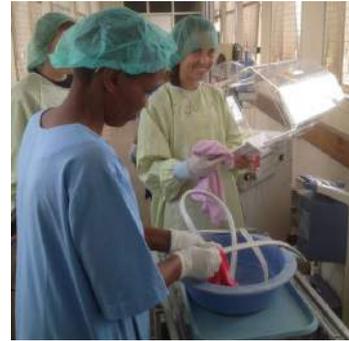
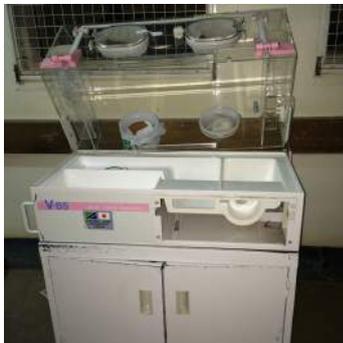
**Figure 3.6:** Cleaning the Incubator

**Figure 3.7:** Cleaning the Incubator

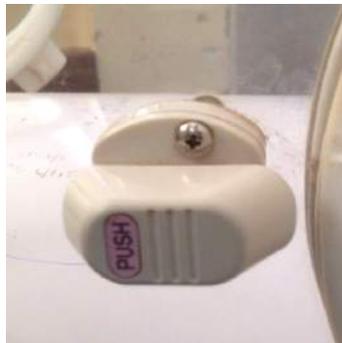
**Figure 3.8:** Incubator Latch Mechanism

**Door Latch** One of the plastic latches which secures the incubator doors had detached from the machine and been replaced with medical tape. The latch consisted of two parts: a push button mechanism and spacer. The latch was found below the incubator, but the spacer was missing. The orthopaedics department fashioned a new spacer based off of the identical one for the other door. The original piece was 7 mm thick, so we used two 4 mm pieces of plastic which we sanded down to a thickness of 7 mm. The orthopaedic department electrically sanded the plastic into the correct shape and drilled holes to finish the spacer.

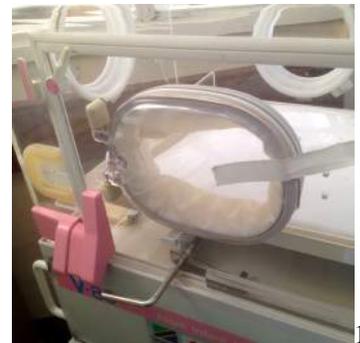
**Figure 3.9:** Incubator Door Opened

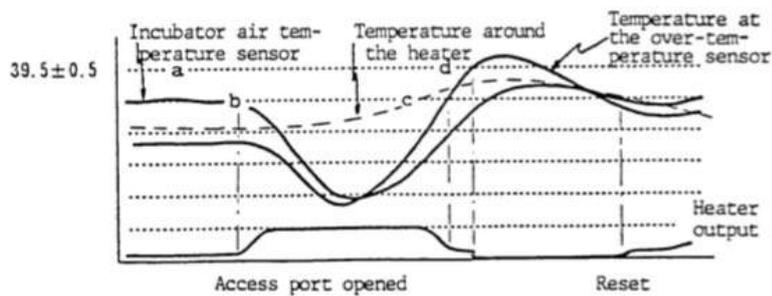
The ICU department had a V-85 Atom Infant Incubator that was donated in 1994 by the Tanzania-Japan Cooperation. The incubator was not used for three years because every time it was powered on, it set off a series of alarms. It was evident that the overheating and ventilation alarms were ringing because the incubator was missing covers to the inlet holes. The heating coil inside of the machine warmed air that rose into the body of the incubator. Because the inlet covers were missing, the warm air escaped from the incubator, and the temperature sensor measured a lower temperature than what would be expected. As a result, the heater was then powered to a higher setting, which raised the incubator temperature to above the maximum allowable threshold. In addition, the lack of these inlet covers interfered with the expected ventilation of the machine, causing the ventilation alarm to sound.

**Figure 3.10:** This diagram describes the behaviour of the internal incubator temperature. When the access port is opened at stage b, the hot air escapes and the internal temperature of the incubator is lowered. As a result, the heater output is increased at stage c to compensate for the lost heat. There is a time delay in the heater's response to internal temperature change, which explains why the internal temperature overshoots at stage d. This causes the over-temperature sensor to set off an alarm.

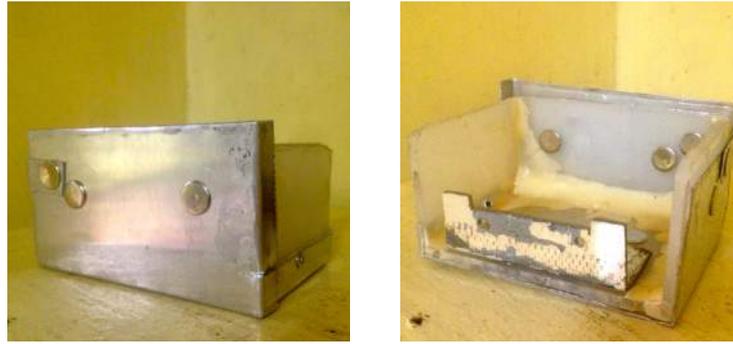
**Figure 3.11:** Incubator humidifier holder.

**Water Humidifier** The final broken piece of the incubator was the water humidifier system, which consisted of an inlet container leading to a water bath inside the machine. As the incubator heated, the water would slowly evaporate and humidify the air inside. The water container and the plastic holder were both broken and unable to be used. The water container was designed specifically to fit onto a tube leading inside the machine, so we decided the best solution was to use a very thick super glue to seal the crack rather than remodel the entire container. The orthopaedics department repaired the holder for the water container by building a small box that screwed onto the incubator. The box was made of a 4 mm thick plastic, cut and held together with a thick super glue. However, the super glue quickly gave way and failed to hold the box together. Thin aluminium sheets and rivets were then added to reinforce the box.

When the final components were attached to the incubator, it was evident that the box would not be sufficient to hold the water container because it was slightly too deep, and therefore failed to provide an adequate platform. The aluminium reinforcements also added extra weight to the component and put stress on the small screws holding it to the incubator. As a result, the holder solution was abandoned and replaced with Velcro strips that were salvaged from an old blood pressure cuff. The Velcro was roughened up with sandpaper to make a tighter connection, then fastened to both the water container and incubator with super glue.

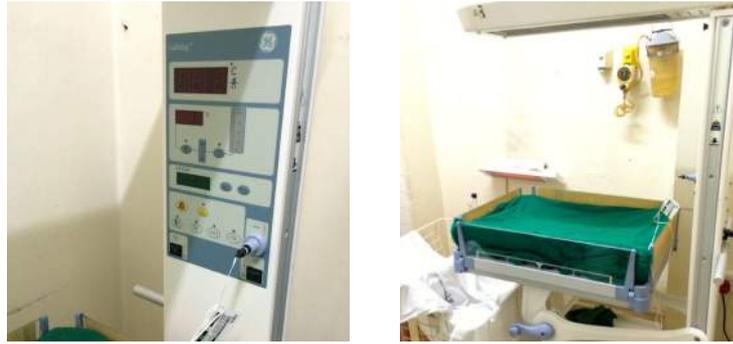
**Figure 3.12:** Left: Infant Warmer at KCMC Maternity Ward. Right: The skin temperature sensor had been placed below the machine, causing the system to overheat.

The first thing we noticed was that the room itself was so hot that the babies could not even be placed directly under the heater. This was caused by the incorrect use of the skin temperature probe. The probe was placed underneath the machine instead of on the infant's body. Therefore, it never measured a temperature of 35.5 degrees Celsius, which the machine was set to. As a result, the heater worked at full power, continually heating the machine and the entire room. Once the temperature sensor was placed up on the mattress pad where the baby would be, the heating power was drastically reduced.

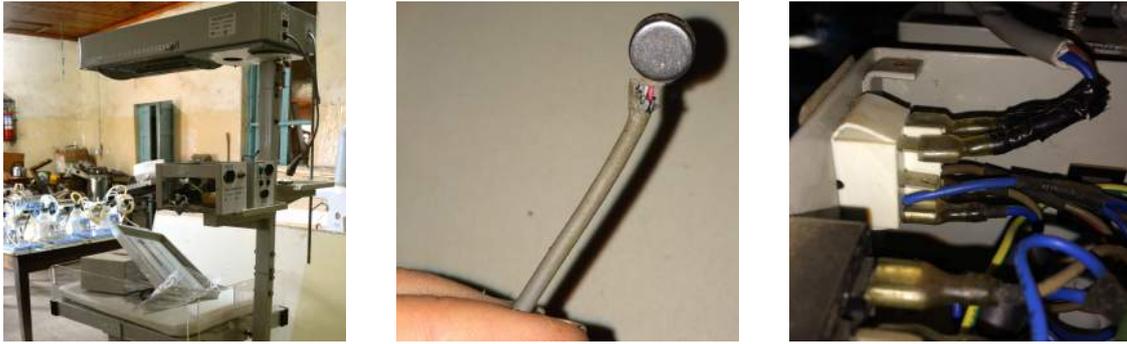
Mawenzi Hospital's maternity ward had an infant warmer that had not been out of order for several years. This machine had several problems that were discovered over a long troubleshooting period. First, an initial inspection identified a faulty connection in one of the two fuses. While the fuse itself was functioning properly, the fuse holder was clogged with dirt. After cleaning the holder, connectivity was restored across the component. The next problem to be tackled involved the malfunctioning circuit board. By testing each component for connectivity or resistance, it was evident that one of the diodes was not working. Diodes should show high resistance in one direction and low resistance in the other, as they only conduct current optimally in one direction. However, the diode in this situation conducted current in both directions, so

**Figure 3.13:** Left: Infant Warmer at Mawenzi Hospital Centre: Broken temperature sensor of the Infant Warmer. Right: Malfunctioning wiring of the Infant Warmer

it was replaced. The infant warmer has a skin temperature-probe which is used to automatically regulate the heating intensity to maintain the baby skin temperature at approximately 35.5 degrees Celsius. The temperature sensor on this specific machine was not working and needed to be replaced. While awaiting a new temperature probe, the machine could still be used in "manual" mode. This requires the hospital personal to closely watch the baby's temperature and regulate the machine accordingly. Using the Infant Warmer in manual mode requires resetting when the machine is turned on. We have developed a quick-start guide explaining how to reset the machine and set it to manual mode. The infant warmer has been given back to the maternity department at Mawenzi Hospital and is now in use.

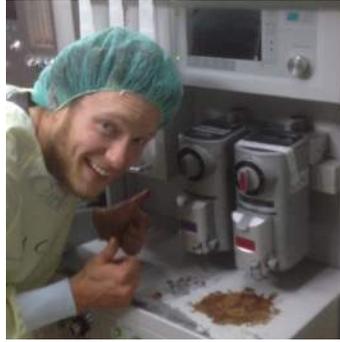
**Figure 3.14:** The isofluorane vaporizer was put back into the anaesthesia machine and is now in use in the surgical department.

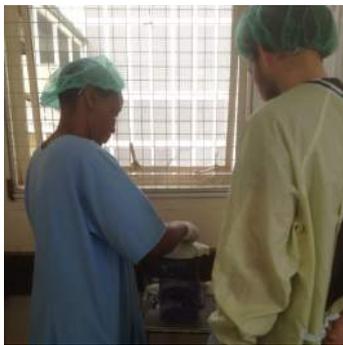
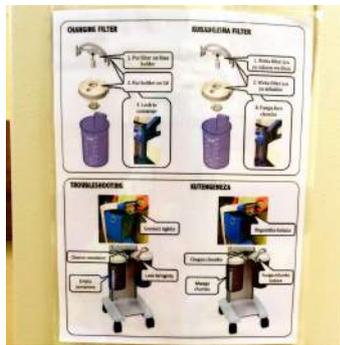
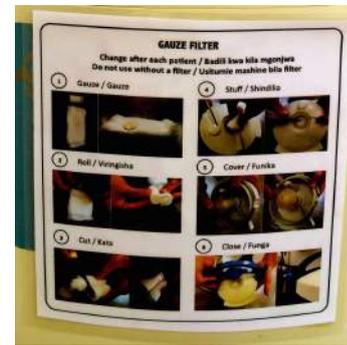
The surgical ICU possessed a relatively new Atmos C 451 automatic suction pump that was not in use. The nurses claimed it sometimes produced suction, but often stopped working. Connecting the power supply proved that the motor was audibly functioning. Next, we checked for leaks in the tubing by removing tubes one-by-one and monitoring the suction; this can help to narrow down the problem area. We also looked for clogs in the tubing, which are commonly seen in suction pumps as a result of their function. The problem was determined to be faulty connections between tubing elements, which can be solved by tightening connections. After testing, we also discovered that the filters – which prevent the suctioned

**Figure 3.15:** Left: David explains how to change the filters in the Atmos suction pump and how to create gauze filters. Centre: We created a laminated quickstart guide for the suction pump. The guide highlights the importance of tight connections in the tubing and includes instructions on how to replace filters. Right: When filters are clogged or missing, a substitute can be made with gauze, as illustrated in this quick-start guide. While this alternative does not function as a bacterial filter, it does protect the motor from getting clogged.

materials from contaminating the motor – were not regularly replaced and had become clogged. We created a troubleshooting guide to explain which connections must be secured and a quick-start guide instructing how to make gauze replacement filters. An identical machine was found in the maternity ward, which was currently being used for C-section surgeries. However, this machine was missing a lid to one of the two collection jars and a filter to the other. Therefore, when the jar had overflowed during a previous surgery, blood had been sucked into the motor. This machine required replacement parts and thorough cleaning of the biohazardous material, which still needs to be accomplished. Additionally, four identical manual suction pumps were collected at Mawenzi Hospital. One of these machines required a replacement collection jar, which was cannibalized from a spare machine. The others had leaky connections at the ends of the tubing because the tubes had stretched over time. This was quickly fixed by cutting off and discarding a small portion of each tube from both ends, and then reconnecting the remaining pieces.

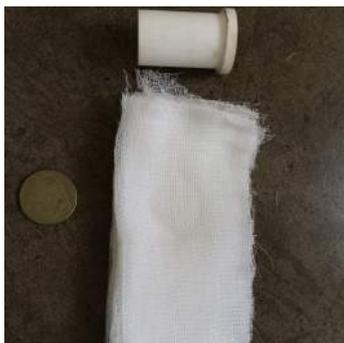
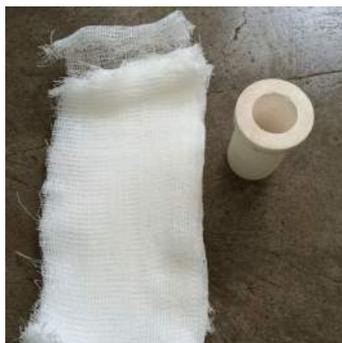
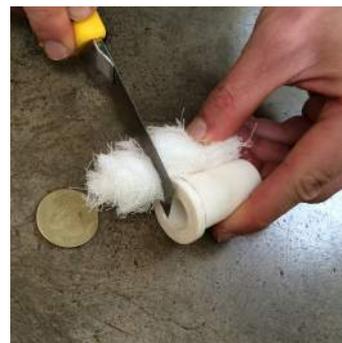
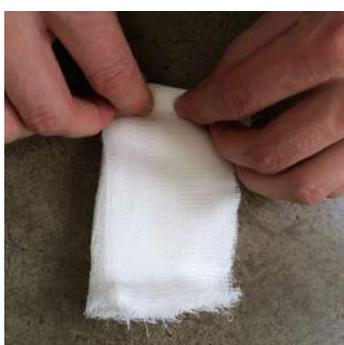
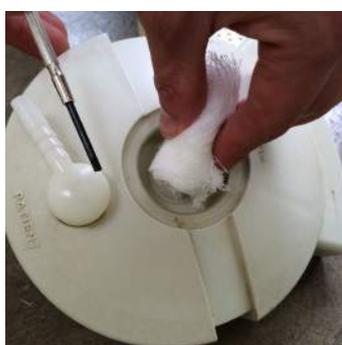
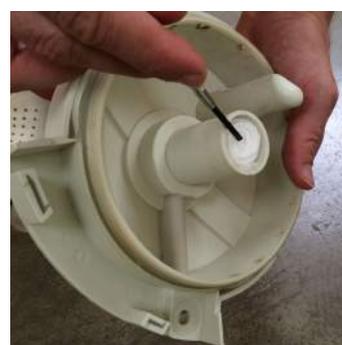
**Figure 3.16:** Gauze

**Figure 3.17:** Creating a Gauze Filter

**Figure 3.18:** Creating a Gauze Filter, cutting to the right size

**Figure 3.19:** Creating a Gauze Filter, Rolling up the gauze filter tightly

**Figure 3.20:** Placing the rolled gauze filter in place of the original filter.

**Figure 3.21:** Placing the Gauze tightly

A main issue we have encountered with many suction pumps is the lack of filters. When the existing filters get clogged with dirt, the suction level is significantly reduced. It is not advisable to simply remove the filter, as it puts the motor at risk of damage from aspirating fluids. A simple and effective alternative to

expensive commercial filters is to create a home-made filter from gauze. Figure 3.16 through 3.21 illustrate how to create a gauze filter for an Atmos suction pump.

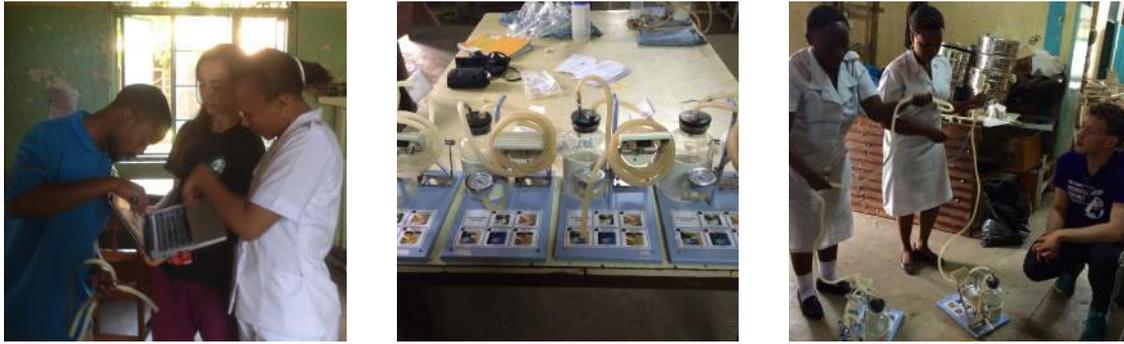
Almost every department at Mawenzi had a manual suction pump that was out of use because of weak suction. After working on four of these pumps, we determined that the major problem was user error. Therefore, we created a quick-start guide and associated training to explain how to properly use the pumps.

**Figure 3.22:** Left: Manual suction pumps at Mawenzi hospital that had been repaired. KJ discusses the details of the quick start manual with a nurse from the medical ward. Centre: Correct use of the manual suction pump requires some special techniques as described in the quick start guide. Right: The quick start guides were supplemented by hands-on training with nurses from each department at Mawenzi hospital.

We had initially planned to train the nurses by demonstrating during one of the Friday morning reports, which all doctors and nurses at Mawenzi Hospital attended. However, the head doctor suggested we train one nurse from each department, who could then teach the others. This would ensure that the nurses present at the training were actively engaged, and had the responsibility to pass along the knowledge to the others in their department. The training consisted of showing the quick-start guide, demonstrating the operation techniques, and then letting the nurses operate the pumps independently. Our quick-start guide, attached to each machine, was pre-checked by a native speaker and practised on several students and nurses before the training session. Five nurses showed up in our workshop after being selected by the head doctor, who also came to our teaching session. This added credibility and weight to our training. We went step-by-step through the quick-start guide while demonstrating each stage. This was done in English, but a couple of the nurses translated for the others in Swahili. The nurses asked questions about the functionality of the machines which we hadn't even considered, such as, "Can we still add water to the bottom of the collection container so that the blood is easier to clean out?" We then had the nurses try for themselves on one of the four suction pumps. Several had trouble holding the tube tightly to maintain the suction, so we went through some troubleshooting steps with them to find the leak. Shortly after this, a few more nurses came to the shop and the nurses whom we had just taught were able to teach the others. The whole process lasted under thirty minutes. Afterwards, the nurses took the pumps back to their respective departments.

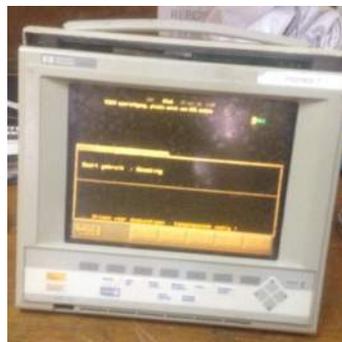
The Medical 2 department has four Hewlett Packard OmniCare 240 Neonatal vital signs monitors that measure blood pressure, heart rate, SpO<sub>2</sub>, and ECG. Out of these four machines, there are zero ECG electrodes, one functional SpO<sub>2</sub> sensor, and three functional blood pressure cuffs. The engineering department

**Figure 5.1:** Cardiac monitor from the SICU and MICU. Several of these machines have been donated to KCMC. Usually the machines work, the most common problem being either the power supply, *SPO*<sub>2</sub>-meter, blood-pressure cuff or lack of ECG electrodes and ECG gel.

should build ECG electrodes, as detailed in the Appendix B, for each machine. The SpO<sub>2</sub> sensors are Philips M1191B sensors that can be purchased directly from Philips through the procurement office. However, the Engineering World Health students will attempt to get these parts donated from Philips due to the high cost (\$423 per piece).

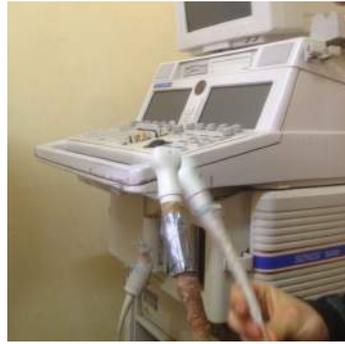
**Figure 5.2:** A problem commonly seen in ultrasound machines is damage from stress and strain at the junction of the cable and transducer cord.

One of the two ultrasounds in the main room of the radiology department is functioning, but has a few keys on the keyboard (B,N, and the space bar) which are stuck. This problem could most likely be quickly remedied with cleaning. The transducer cords for both of these machines have broken cord coverings which have been repaired with duct tape. A more sustainable solution would be help maintain the longevity of these machines.

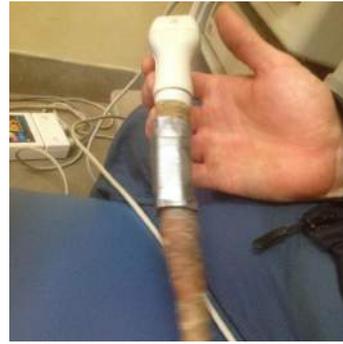
**Figure 5.3:** Close-up of typical transducer found at KCMC.

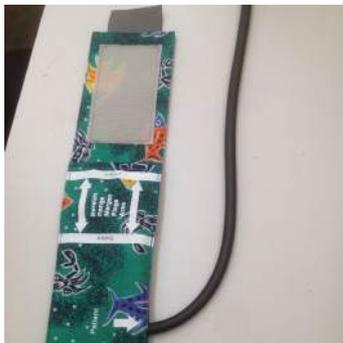
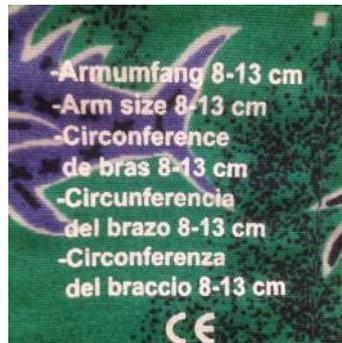
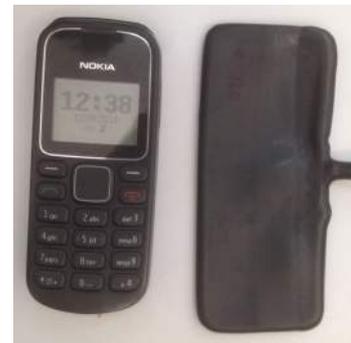
**Figure 5.4:** Paediatric blood-pressure cuff

**Figure 5.5:** Circumference

**Figure 5.6:** The paediatric-size bag that needs to be designed and attached to a tube.

**Paediatric Blood Pressure Cuffs** The paediatric, medical, and neurology departments have no paediatric blood pressure cuffs, and therefore do not have the capability to measure the vitals of these patients. The departments use adult cuffs on some older children, but the readings are consistently low and inaccurate. We recommend that KCMC invest in the procurement of paediatric blood pressure cuffs for each of these departments so that children can be monitored correctly. The risks faced by failing to monitor infant and child patients are too high to ignore the lack of paediatric blood pressure cuffs.

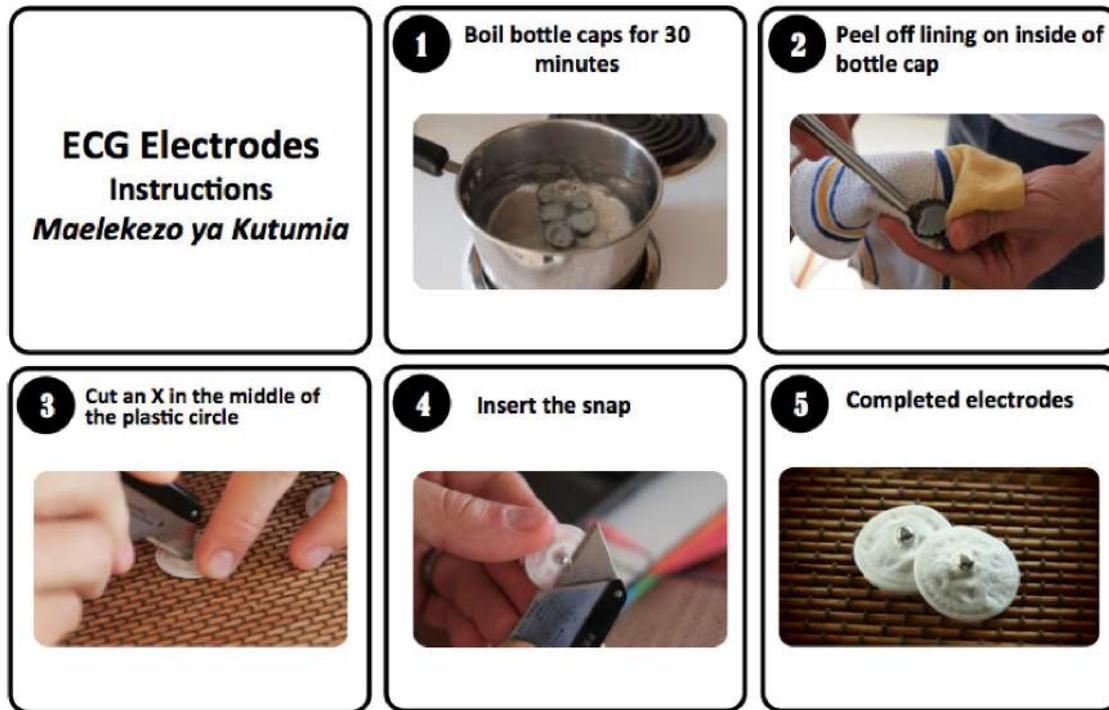
**Figure B.1:** Instructions on how to make ECG electrode pads

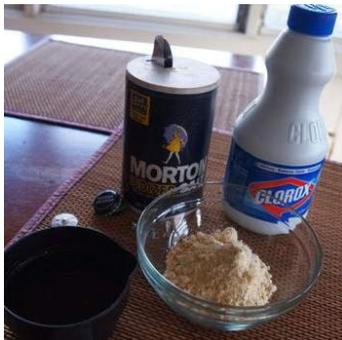
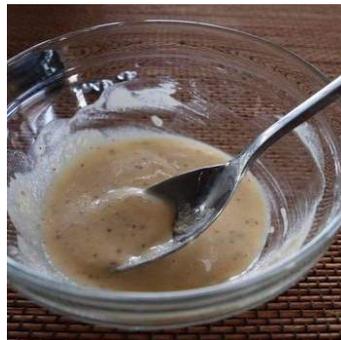
**Figure B.2:** Ingredients for conductive gel

**Figure B.3:** Final consistency of conductive gel

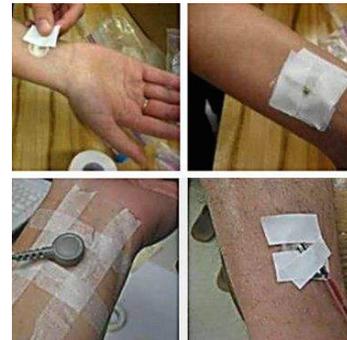
**Figure B.4:** Application of homemade ECG electrodes

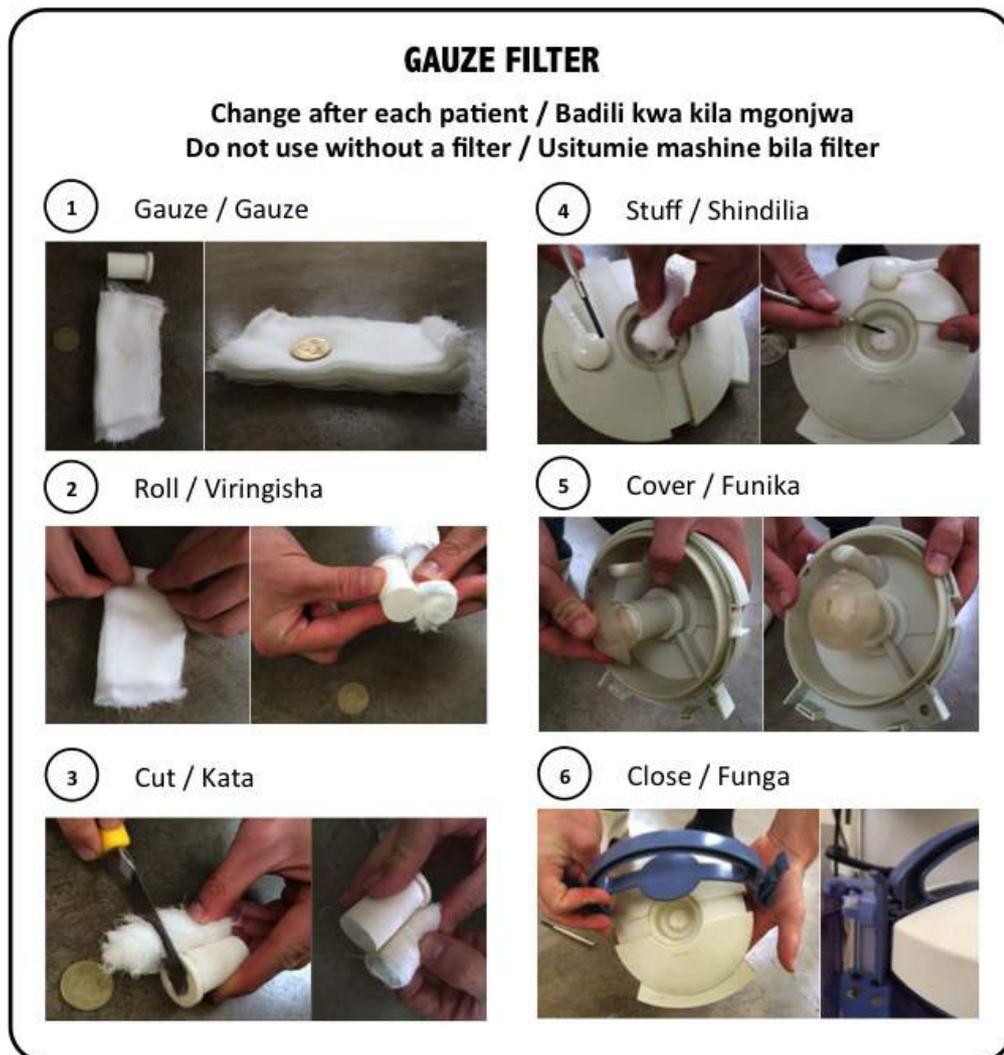
**Figure B.5:** Quickstart guide for making disposable gauze filters

Each suction pump is equipped with a gauze filter that prevents the transmission of fluids from the collection jar into the motor and main body of the machine. These filters are meant to be disposable and changed after every patient. However, in the developing world where consumable materials are largely unavailable, these filters are used repeatedly until they become clogged and cause the machine to stop functioning. The guide below gives instructions on how to make home-made disposable filters out of gauze, which is available in almost every department. These filters should be replaced after every patient or after the filter becomes dirty when being used on the same patient for a prolonged period of time.

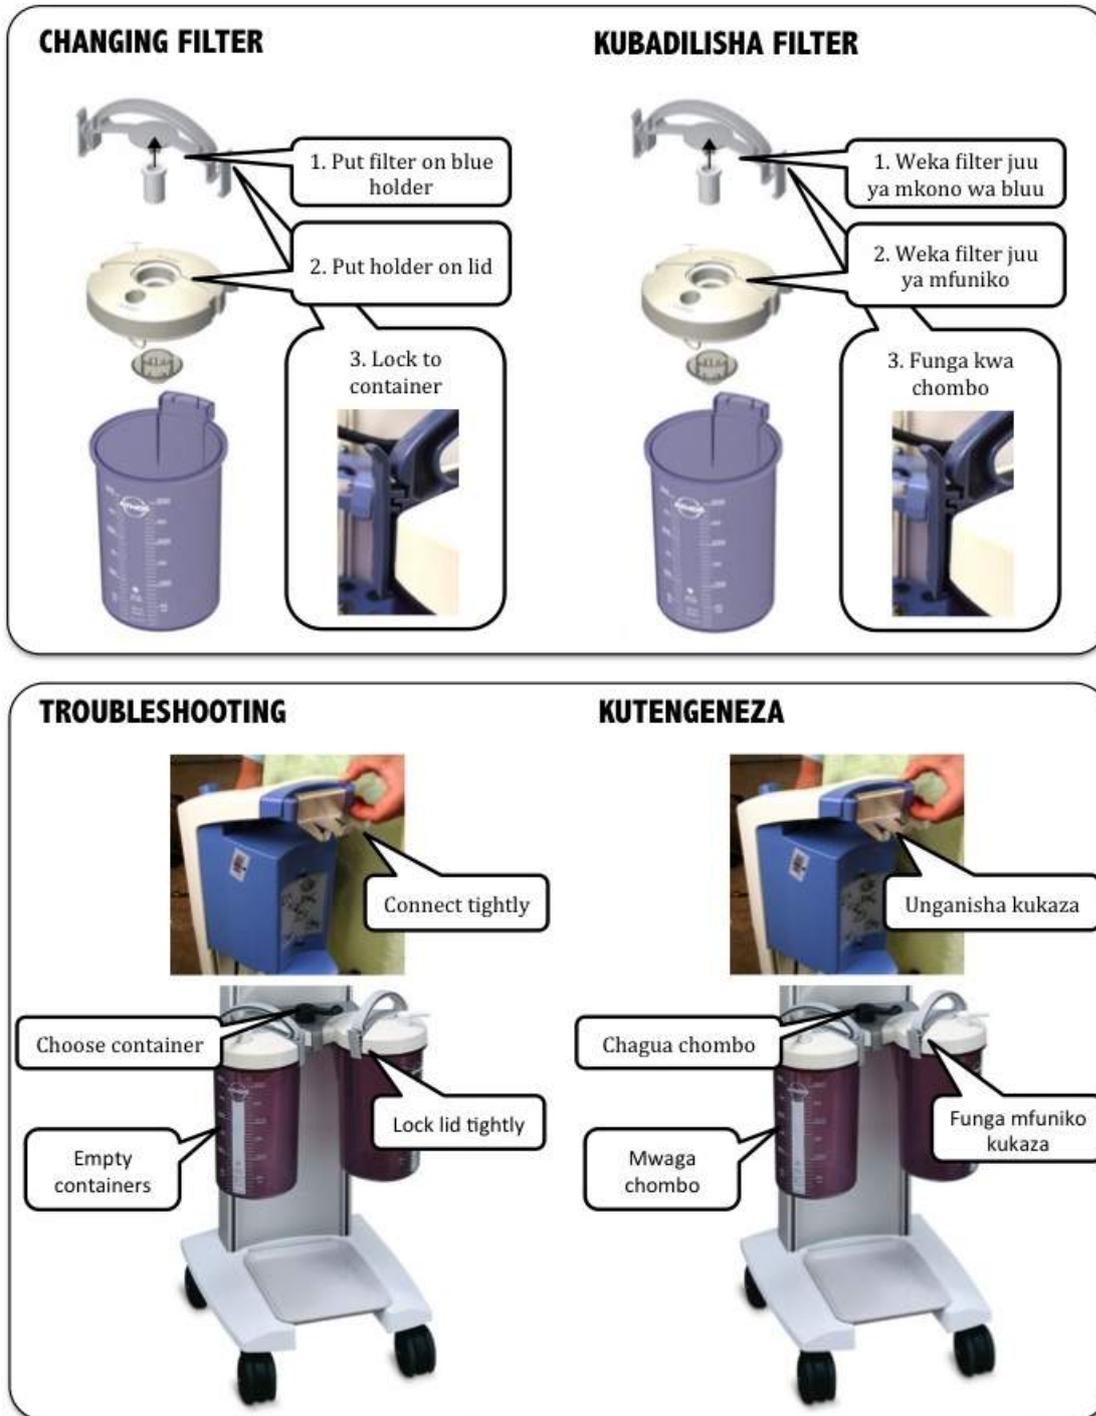
Figure B.6: Instructions on how to change filters and troubleshooting for the Atoms suction pump

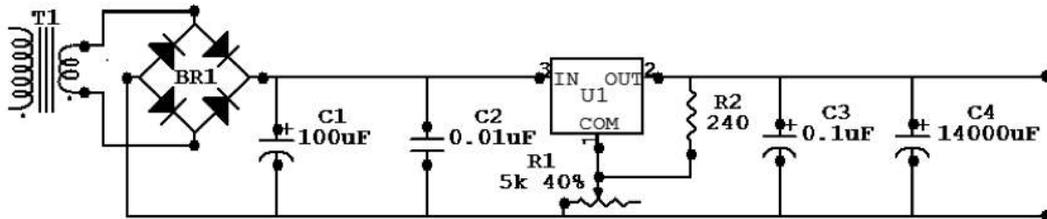
**Figure C.2:** Schematic diagram of variable power supply circuitry

- Capacitor, 14000uF 40V DC
- Capacitor, 0.1 uF
- Capacitor, 0.01uF disc
- Resistor, 5kOhm pot
- Resistor, 240 Ohm, 0.25W
- Regulator, 1.2 V - 32V 5A
- Regulator heat sink
- Transformer
- Fuse and holder
- 2 Alligator clips
- PCB board
- Wire
